Manhole Inspection Summary

Manhole # S49A__059MH

Insp Date: **4/30/09 3:49 PM**

Location Address: **438 ROSE-LUZERNE-ALLEY**

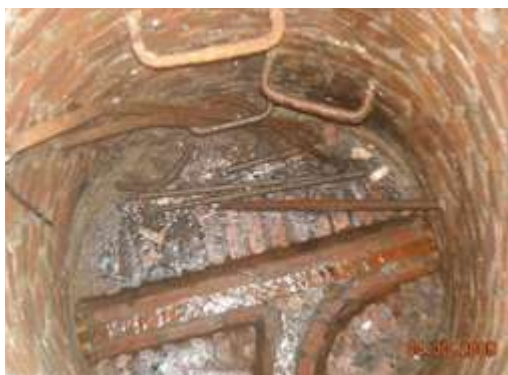
Misc

Condition: ☐ Sound ☐ Cracked ☐ Root Intrusion ☐ Deteriorated ☐ Leaks ☒ **Debris**

DEBRIS ON BENCH

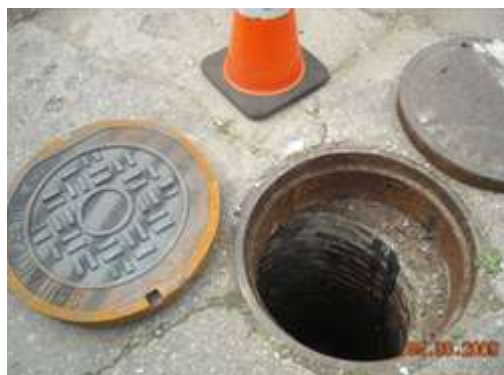
MISC.

REPLACED CRACKED COVER

Comments **OPENNED WITH 16LB MAUL, HYDROLIC JACK, AND SPRAY LUBRICANT; REPLACED CRACKED COVER (see photos)**

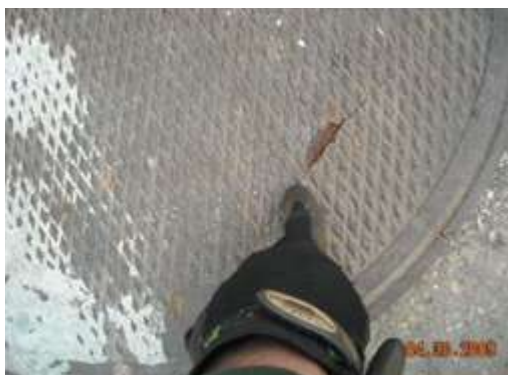
MISC.

CRACKED OLD COVER

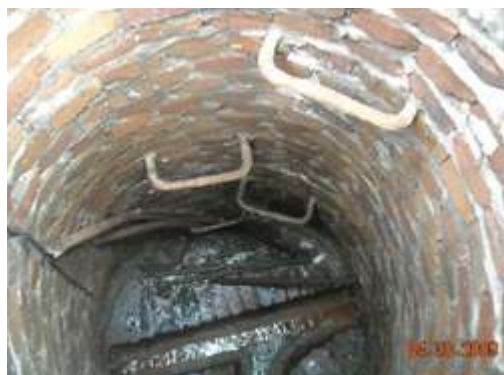
Defect 3

☒ **Corroded**

CORRODED STEPS

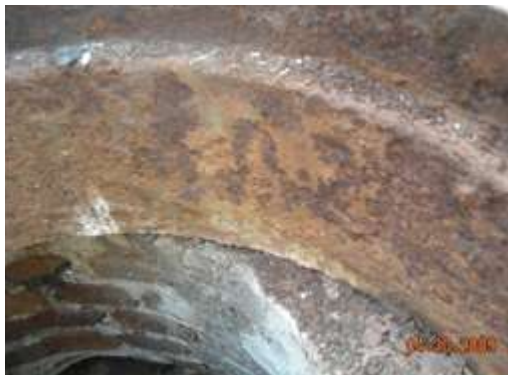
Defect 2

☒ **Leaks**

FRAME LEAKS

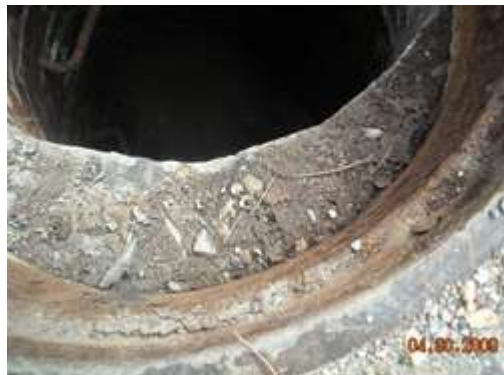
Defect 1

Offset: **5** (in.)

FRAME OFFSET
